**CONSENT ORDER
ISSUED UNDER THE
WATER POLLUTION CONTROL ACT
WEST VIRGINIA CODE, CHAPTER 22, ARTICLE 11**

TO: MarkWest Liberty Midstream & Resources, L.L.C. DATE: March 28, 2019
Gregory Bezdek, SVP, NE Region
4600 J Barry Ct. Ste 500
Canonsburg, PA 15317 ORDER NO.: 8945

MARKWEST LIBERTY MIDSTREAM & RESOURCES, L.L.C, WVR311004, Sherwood to Mobley
20" NGL, 8/22 & 8/23/2018

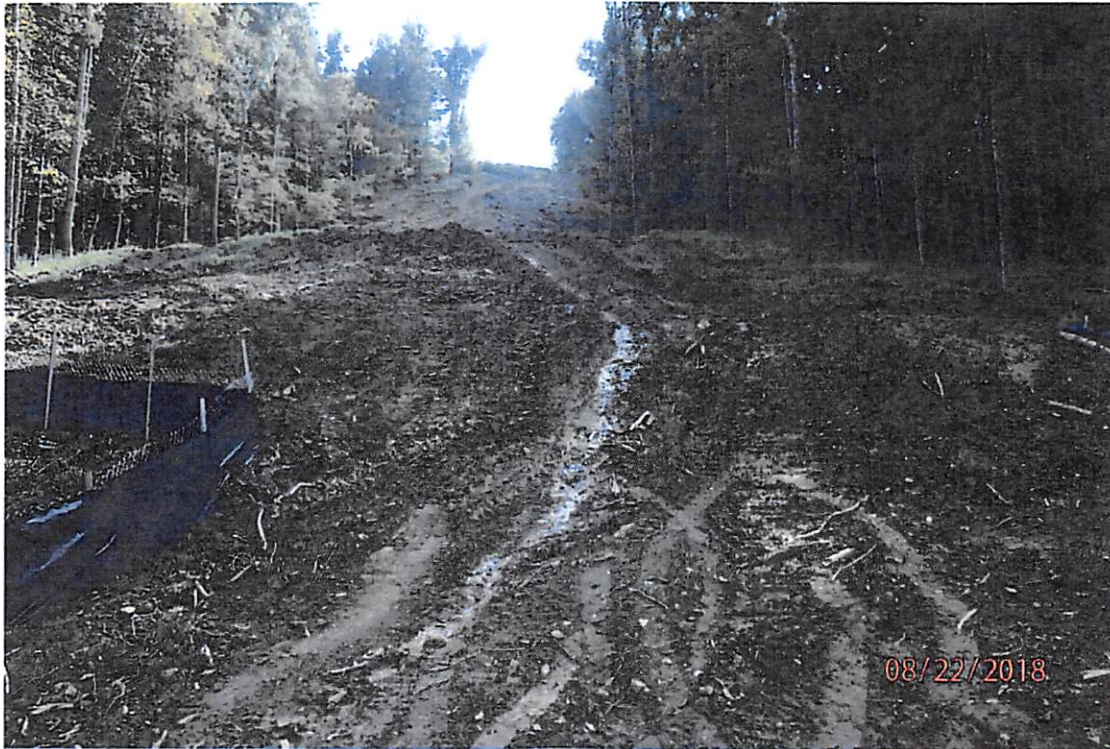
Project area south of the Riggins Run crossing showing a lack of installed water bars.

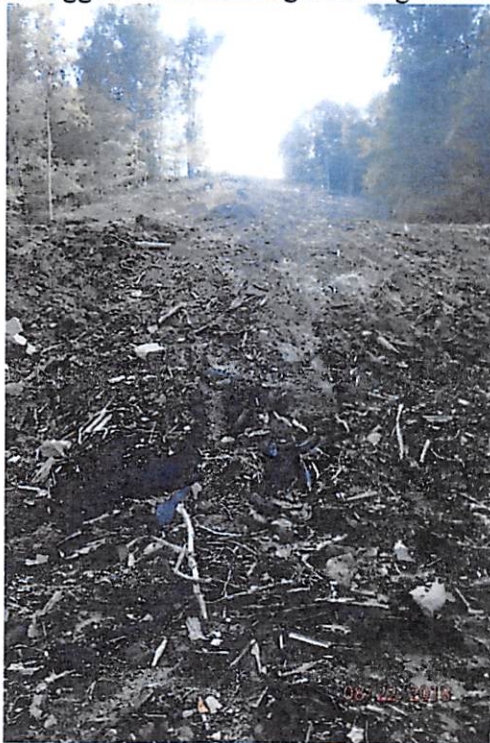
Project area south of the Riggins Run crossing showing erosion gullies as a result of the lack of installed water bars.

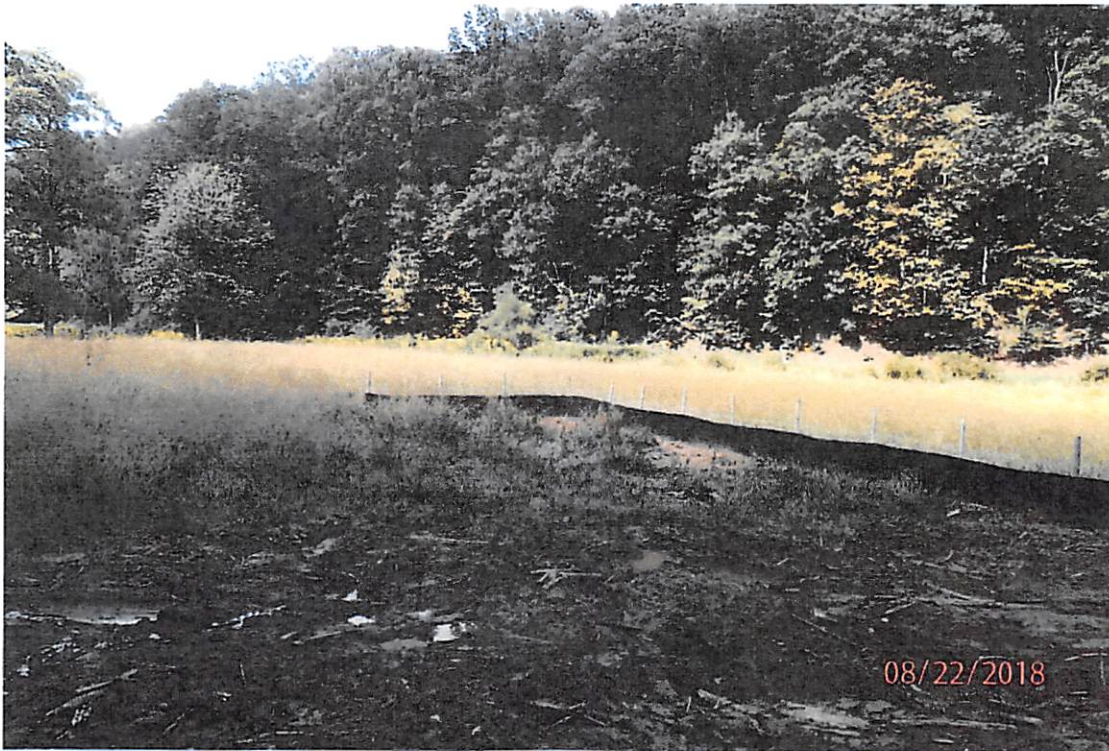
BMP that has been overwhelmed south of the Riggings Run crossing as a result of a lack of installed water bars.

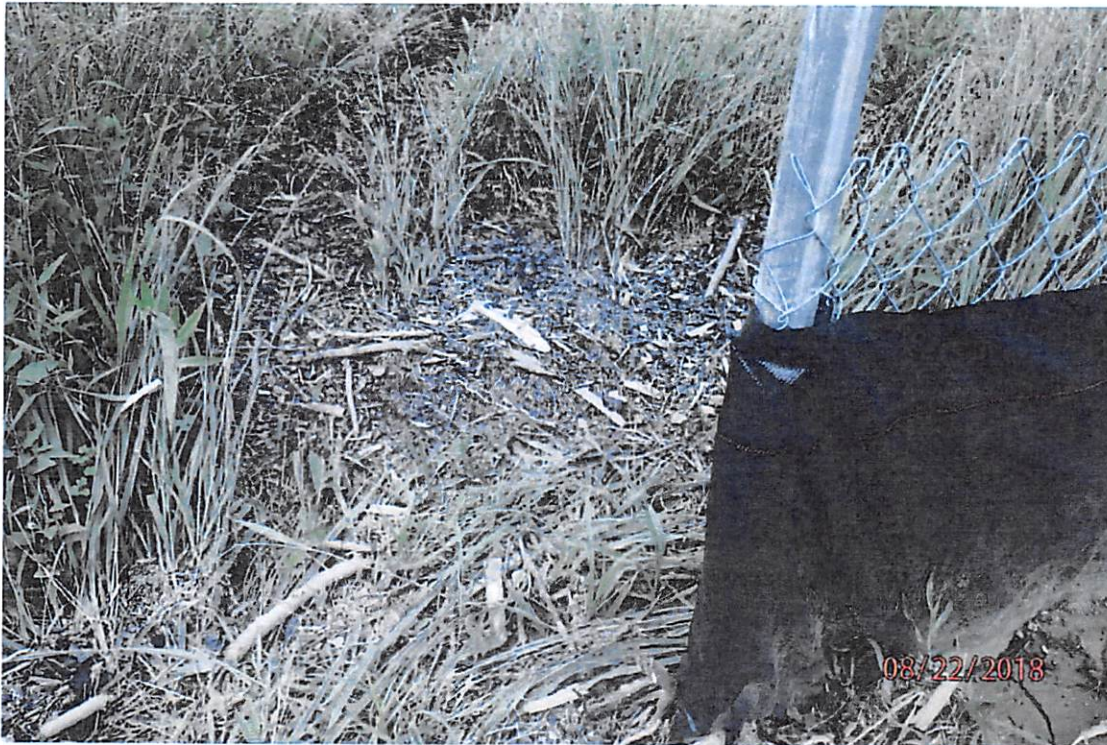
BMP that has been overwhelmed south of the Riggings Run crossing as a result of a lack of installed water bars.

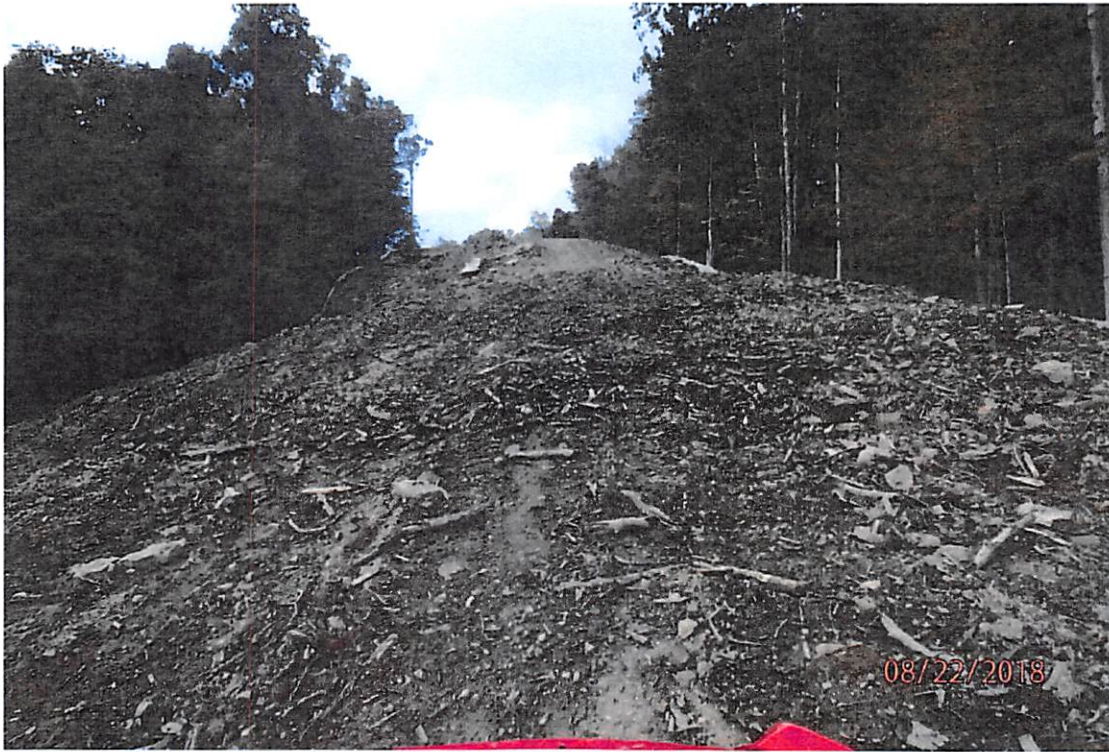
Project area north of the Riggins Run crossing showing a lack of installed water bars.

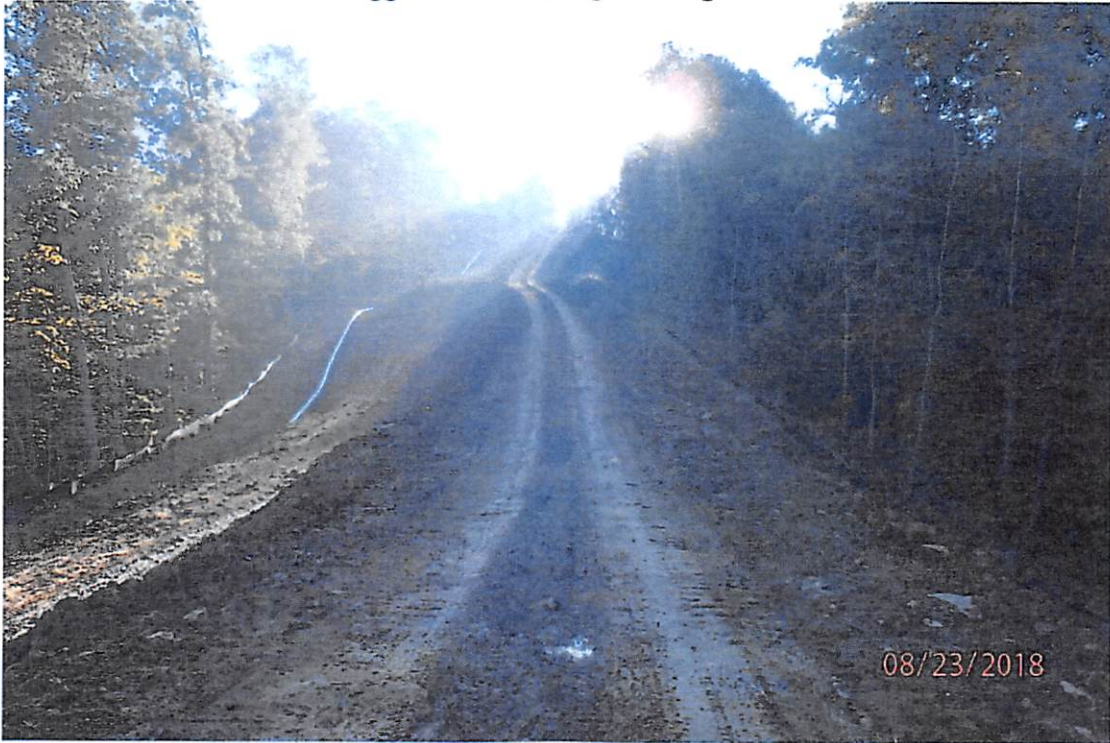
Project area in the Franks Run watershed near 826+00 showing a lack of installed water bars.

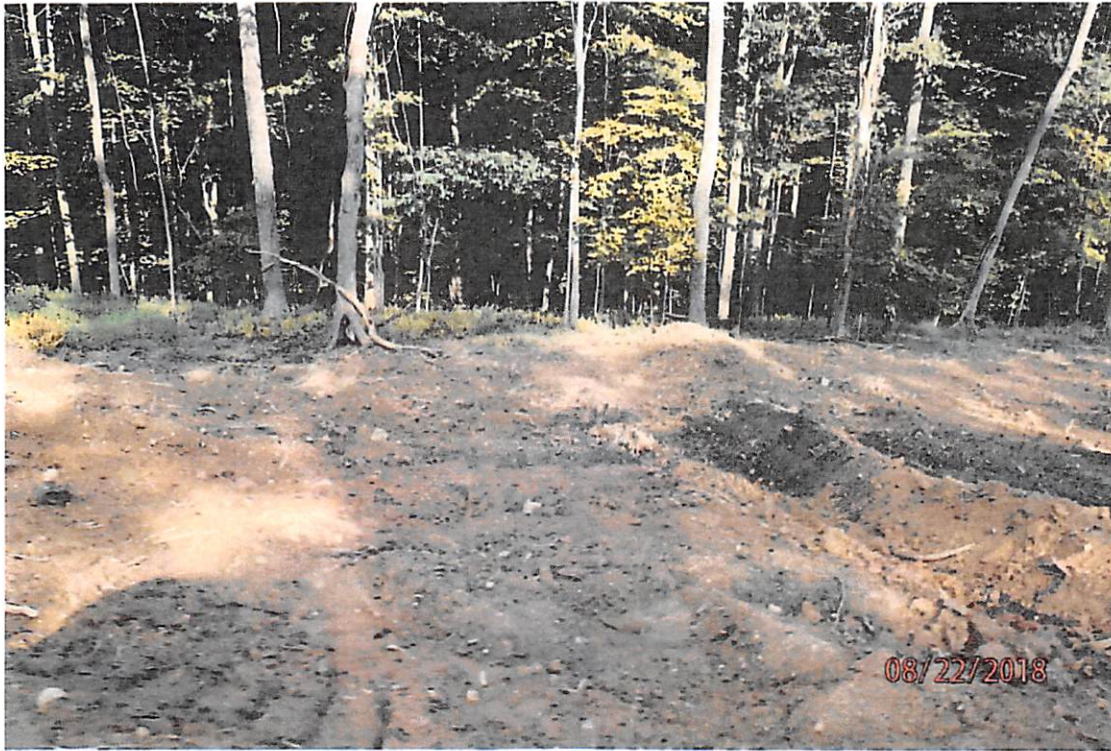
Project area adjacent to 442+00 showing a lack of water bar terminus BMPs.

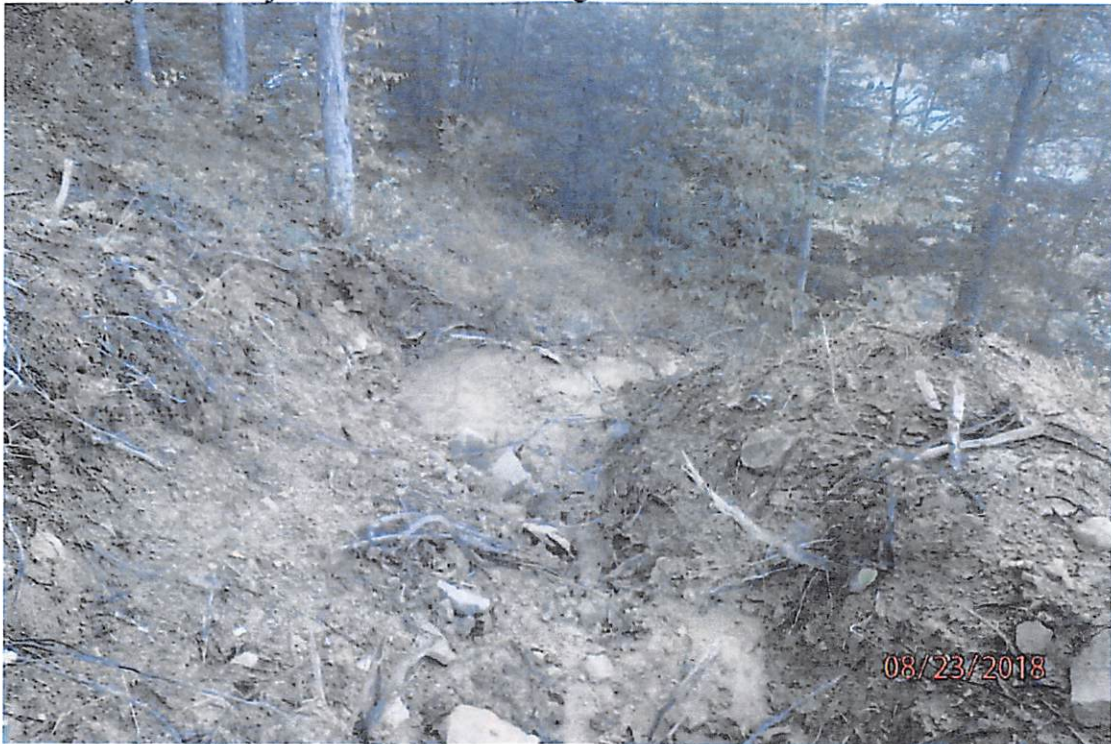
Project area adjacent to 813+50 showing a lack of water bar terminus BMPs.

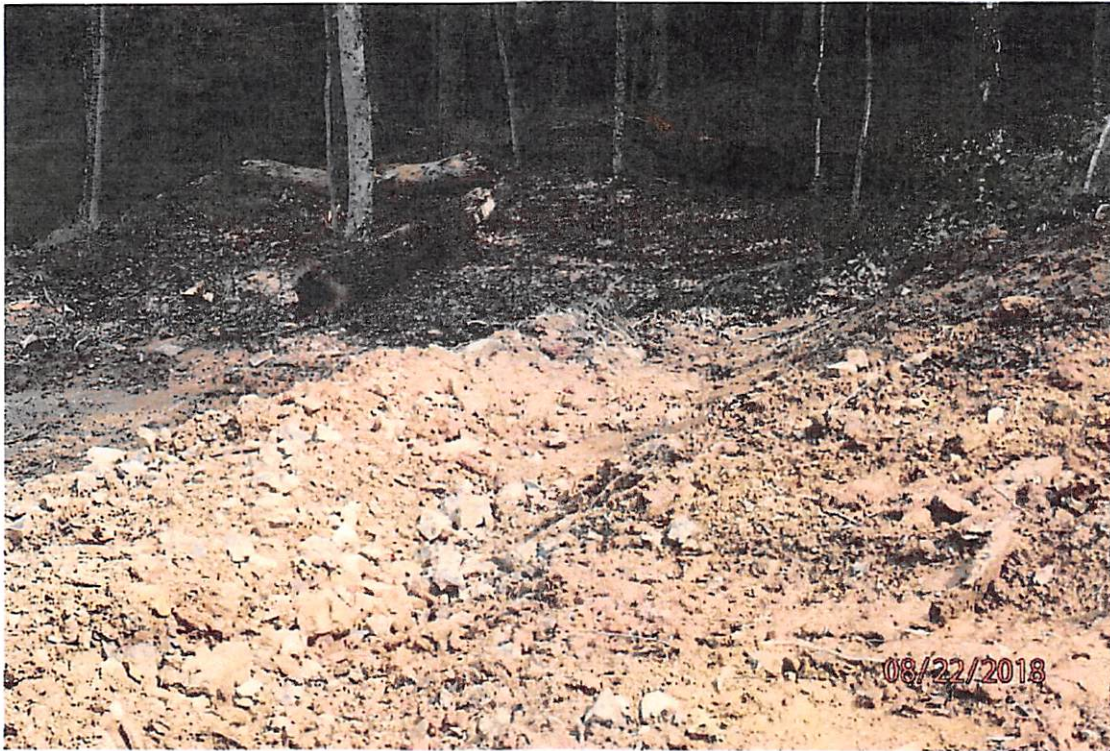
Project area in the Flint Run watershed showing a lack of water bar terminus BMPs.

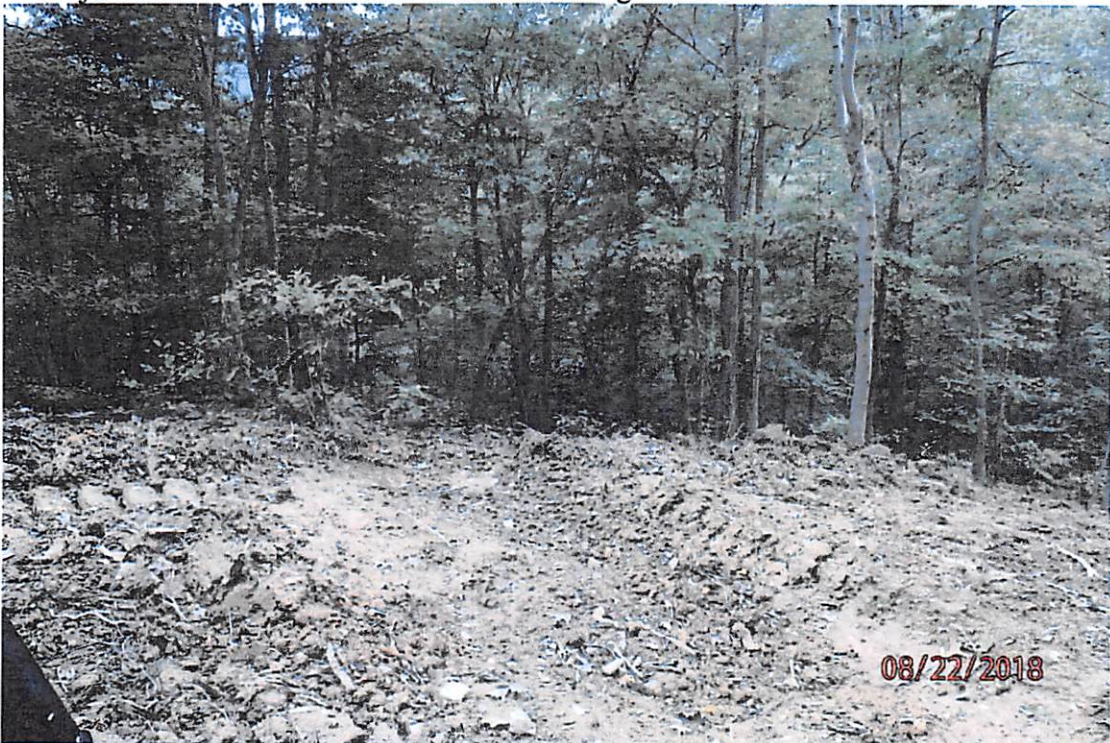
Project area on AR-10 in the Flint Run watershed showing a lack of water bar terminus BMPs.

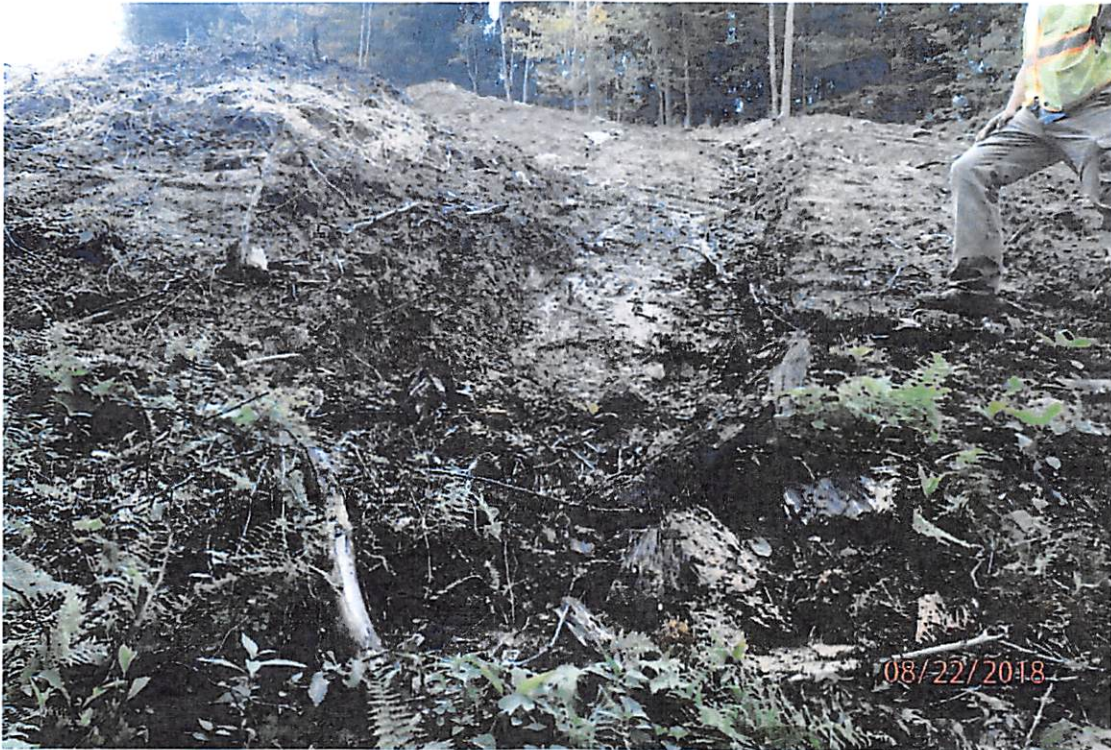
Project area in the Morgans Run watershed showing a lack of water bar terminus BMPs.

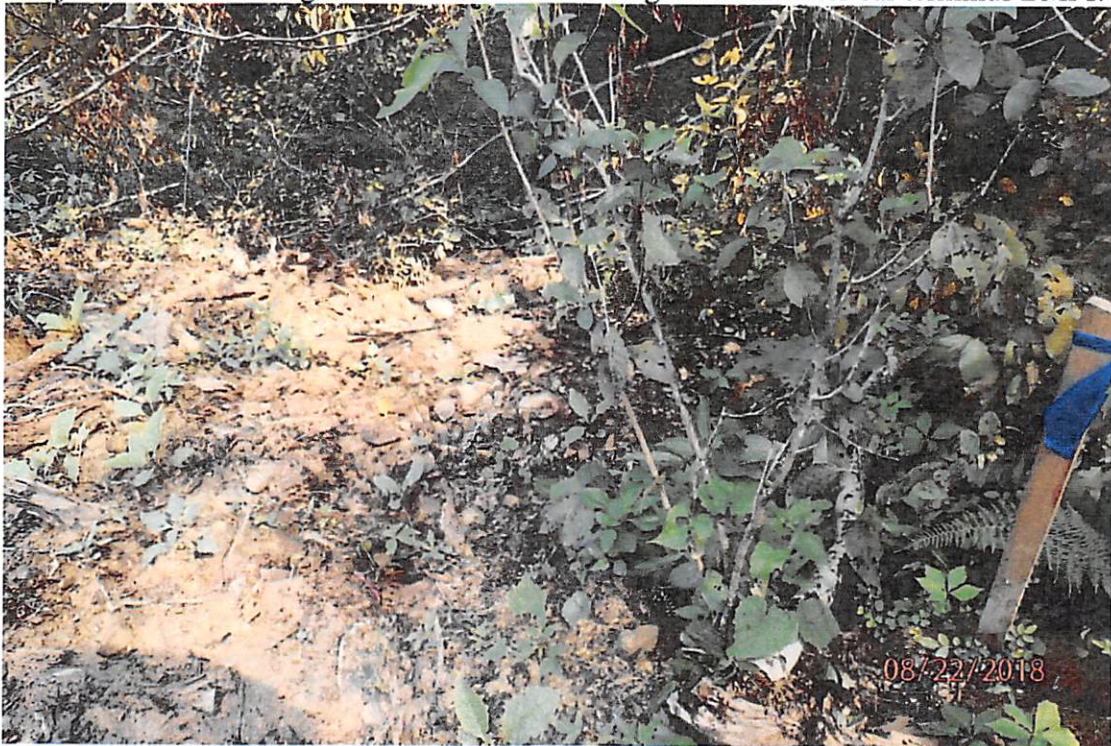
Project area in the Morgans Run watershed showing offsite deposits that lead to the receiving stream as a result of a lack of water bar terminus BMPs.

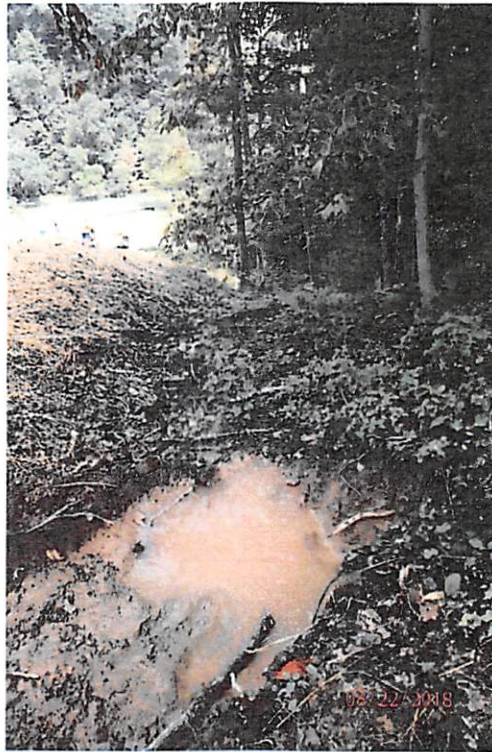
Project area in the Morgans Run watershed showing a lack of water bar terminus BMPs.

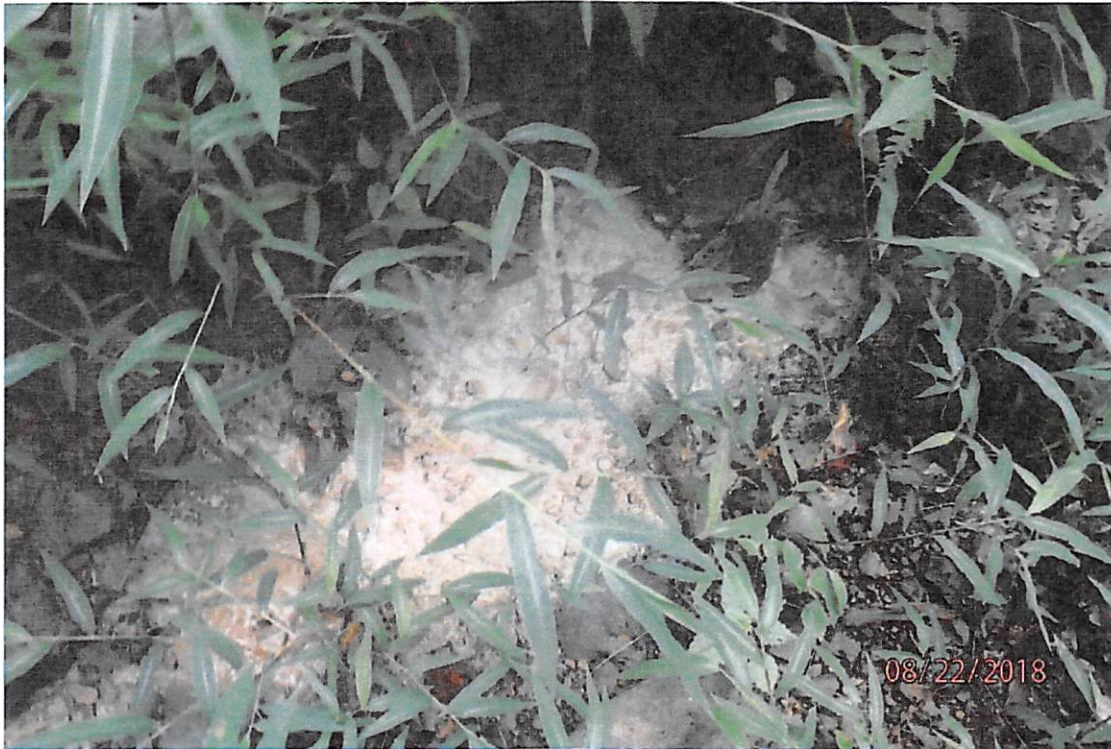
CNA deposits in UNT Morgans Run (UNT 160) ($39^{\circ} 18.488'$ X $80^{\circ} 40.335'$) as a result of a lack of installed water bar terminus BMPs

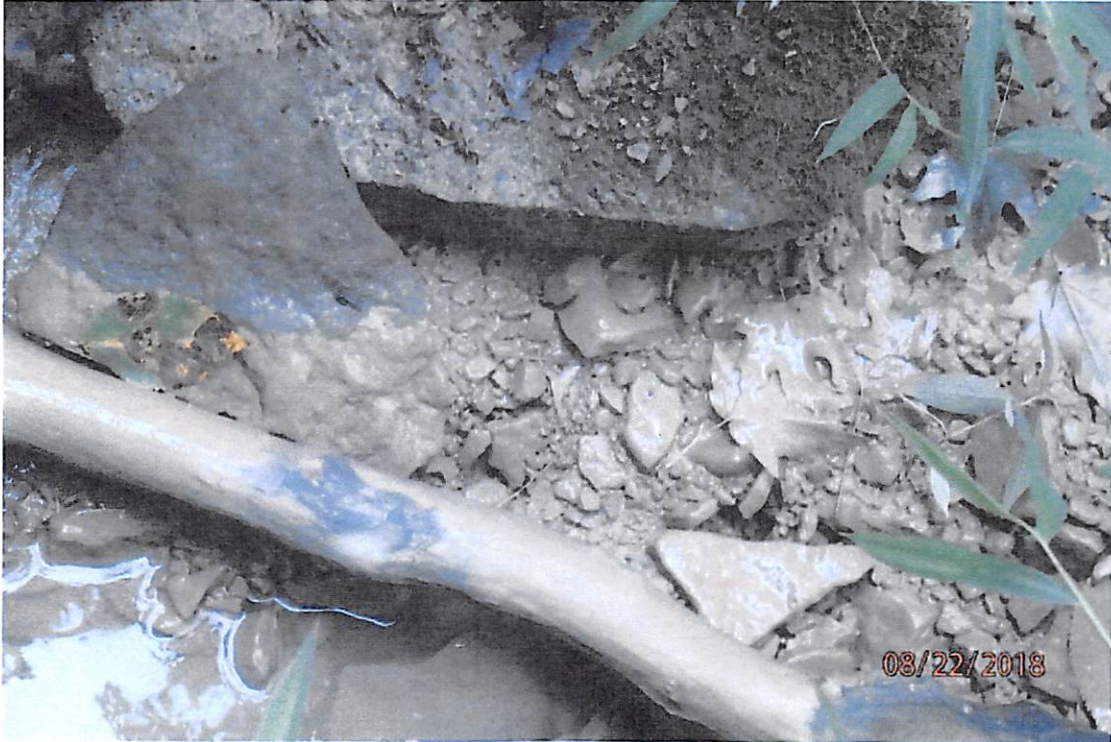
CNA deposits in UNT Morgans Run (UNT 160) ($39^{\circ} 18.488'$ X $80^{\circ} 40.335'$) as a result of a lack of installed water bar terminus BMPs.

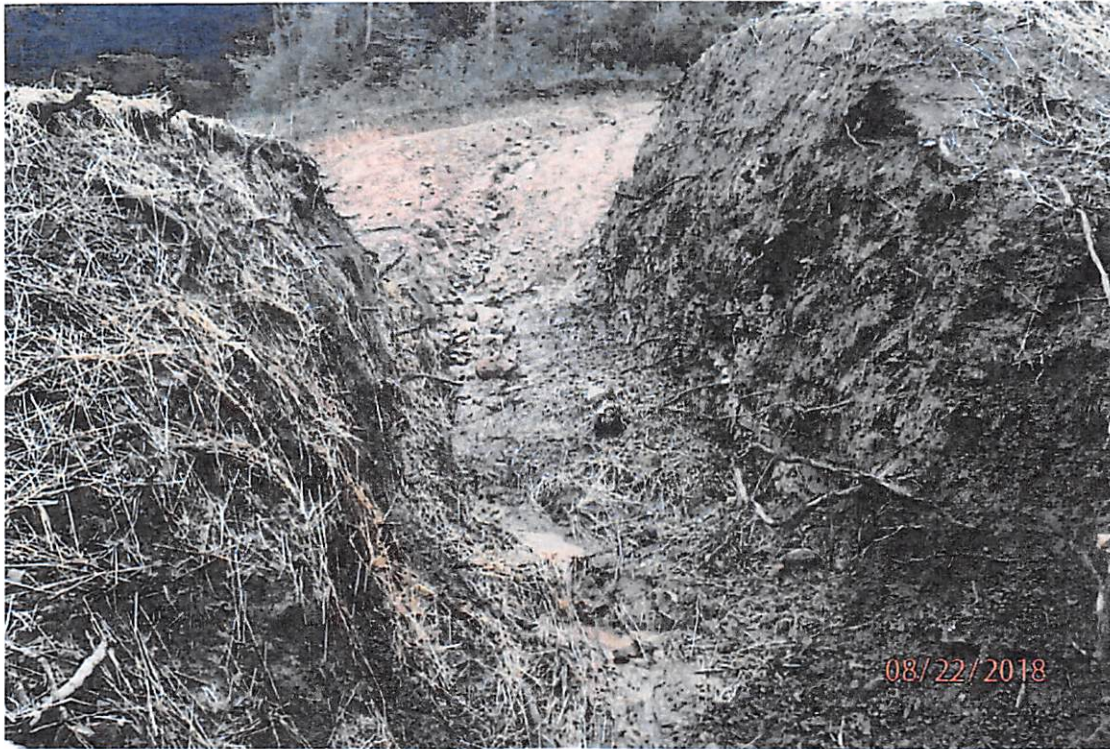
Water bar in the Morgans Run watershed that was installed at a steep angle showing erosion of the BMP.

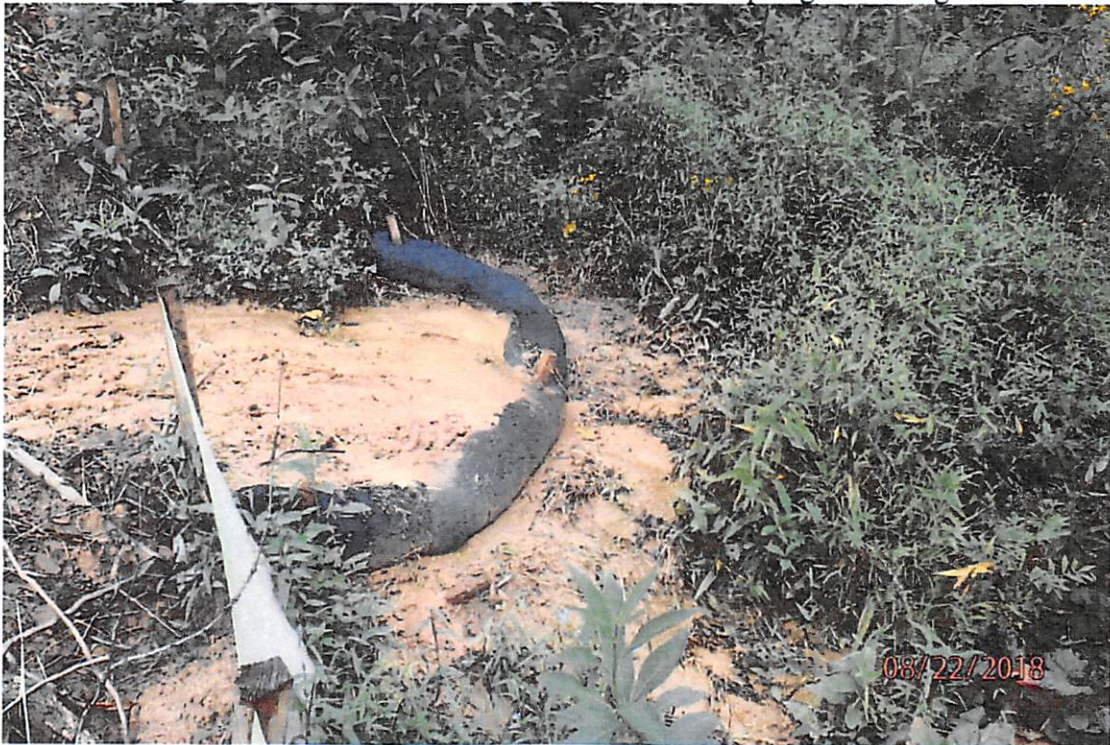
Overwhelmed water bar terminus BMP as a result of excessive erosion from the above pictured water bar.

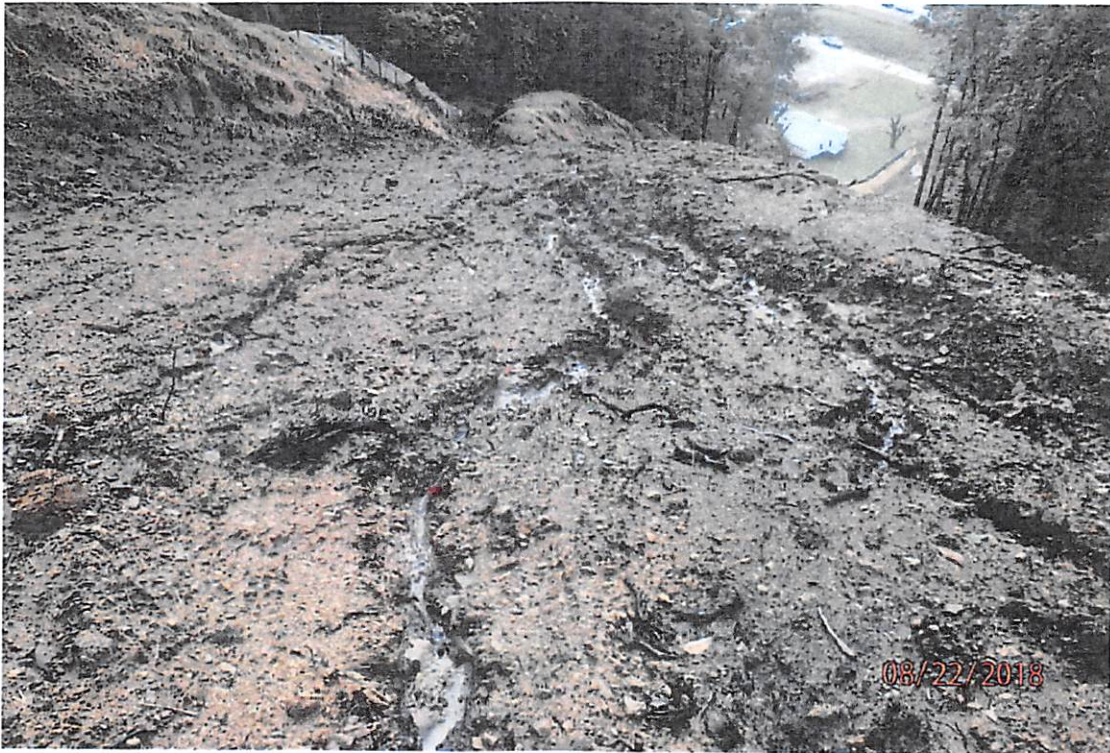
Water bar in the Morgans Run watershed that was installed at a steep angle showing erosion of the BMP.

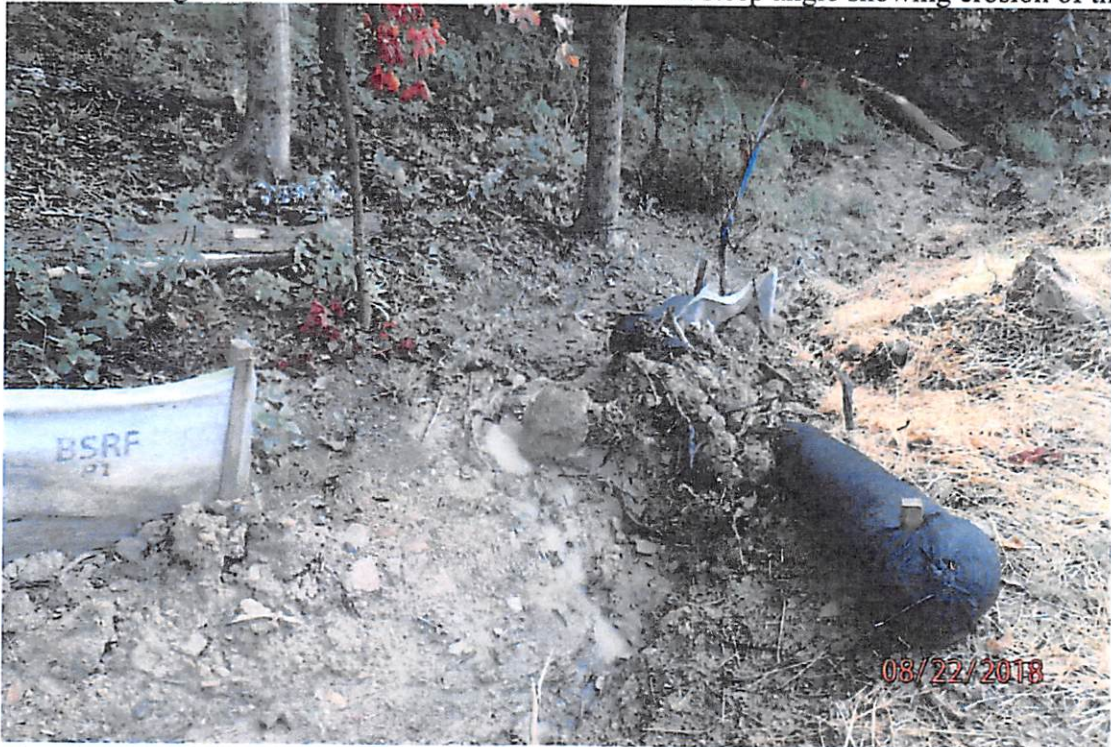
Overwhelmed water bar terminus BMP as a result of excessive erosion and increased water velocity from the above pictured water bar.

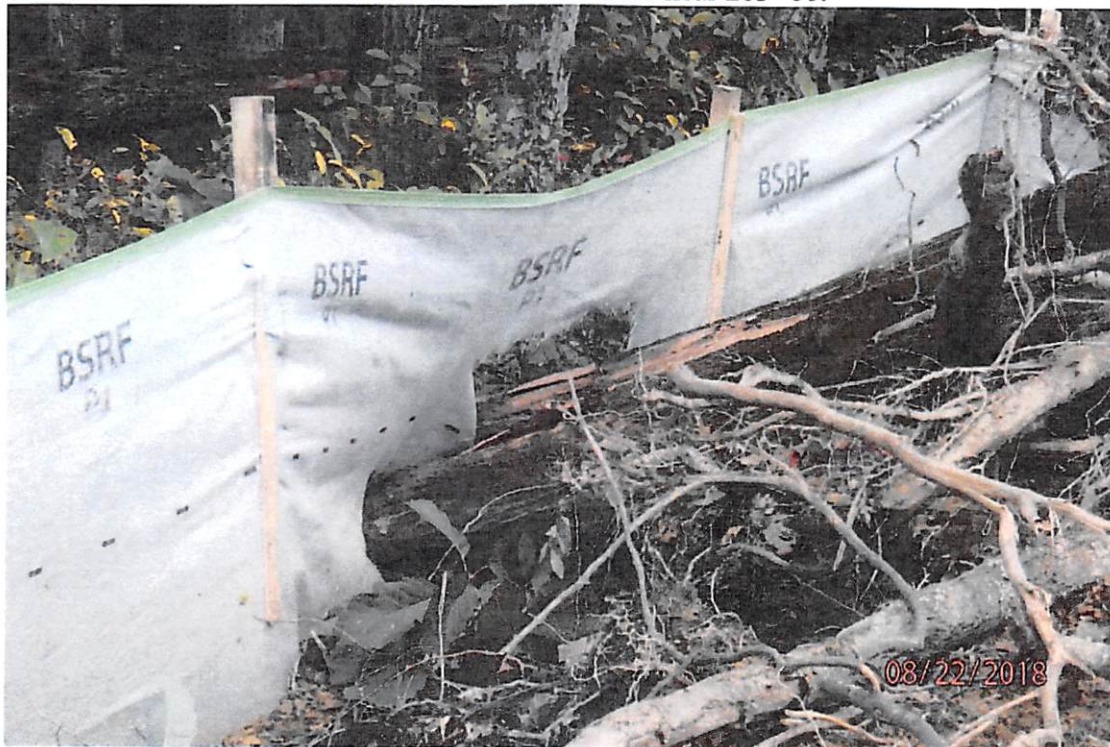
BMP in need of maintenance in the Flint Run watershed.

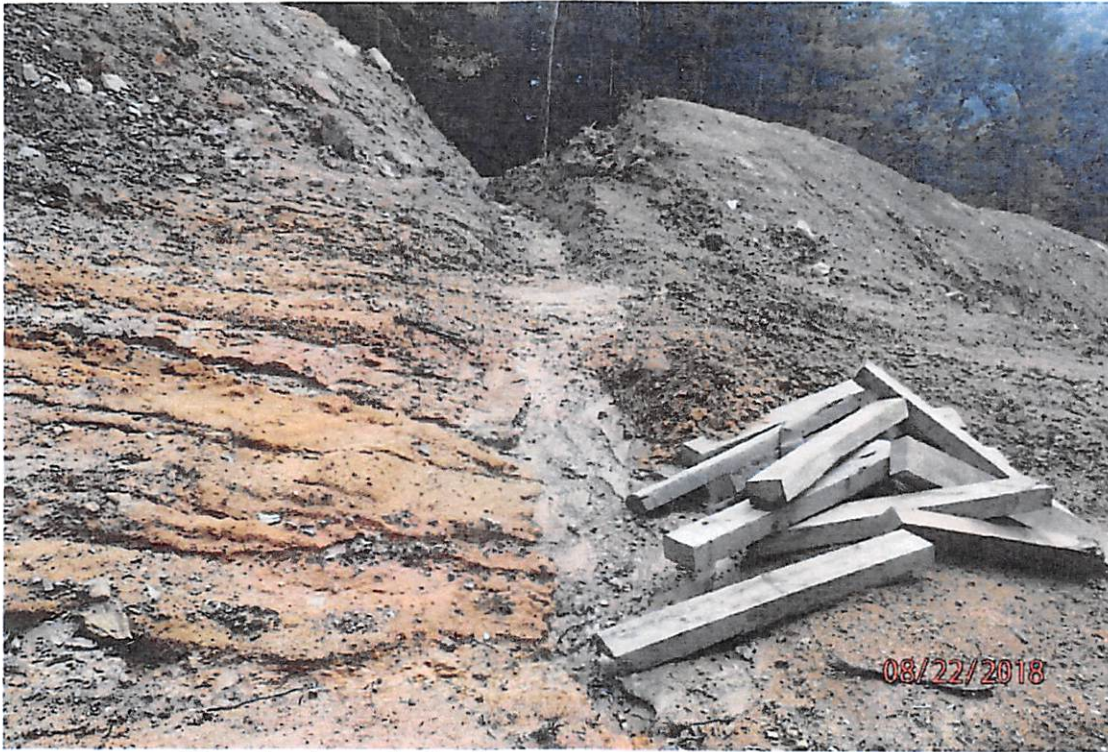
Water bar in need of maintenance in the Flint Run watershed.

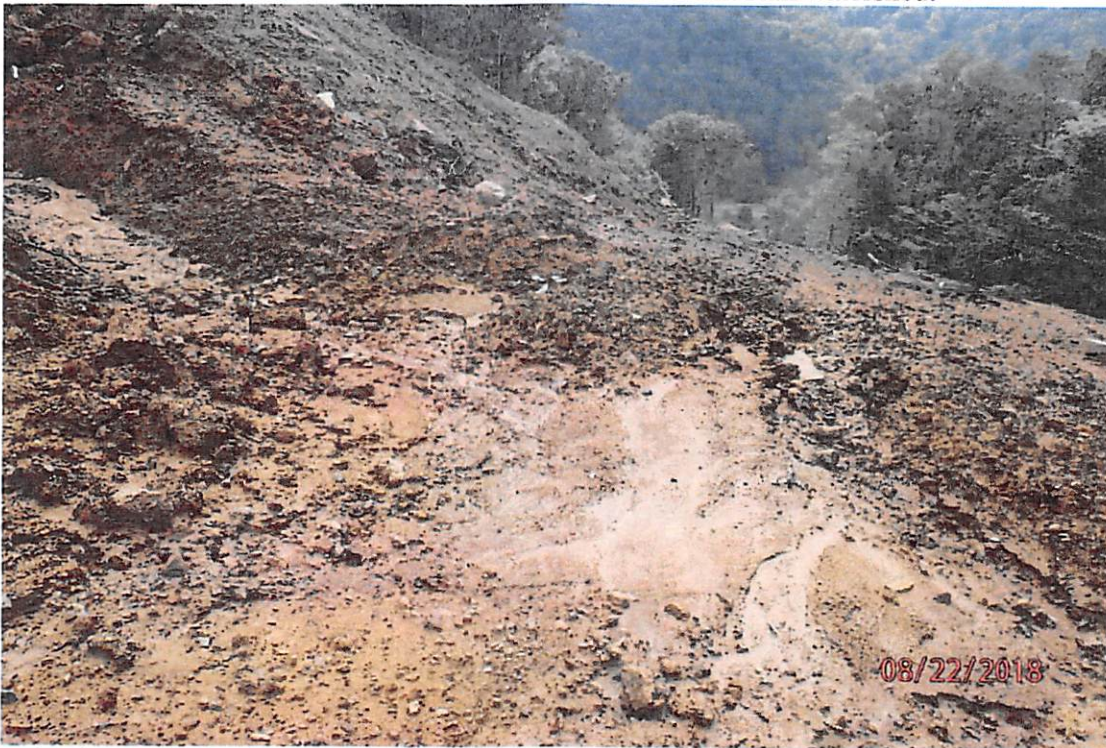
Water bar in need of maintenance in the Flint Run watershed and the associated fill slope erosion.

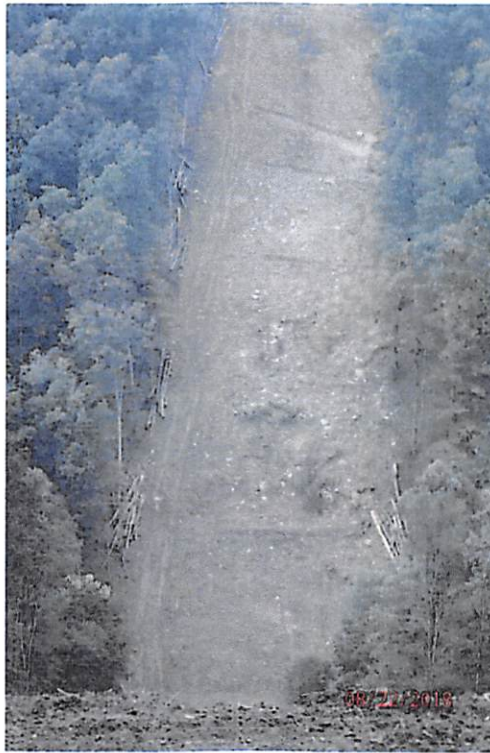
Water bars in need of maintenance (No activity for several days according to site rep.) near 437+00.

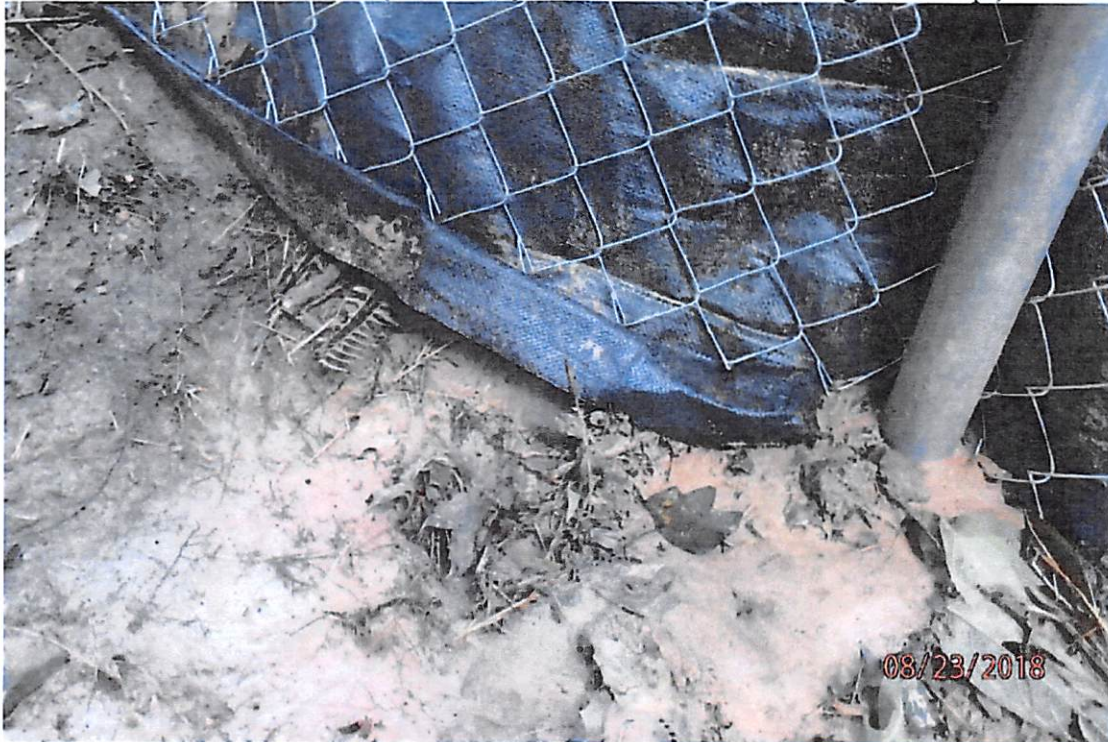
Perimeter control near 863+00 in need of maintenance.

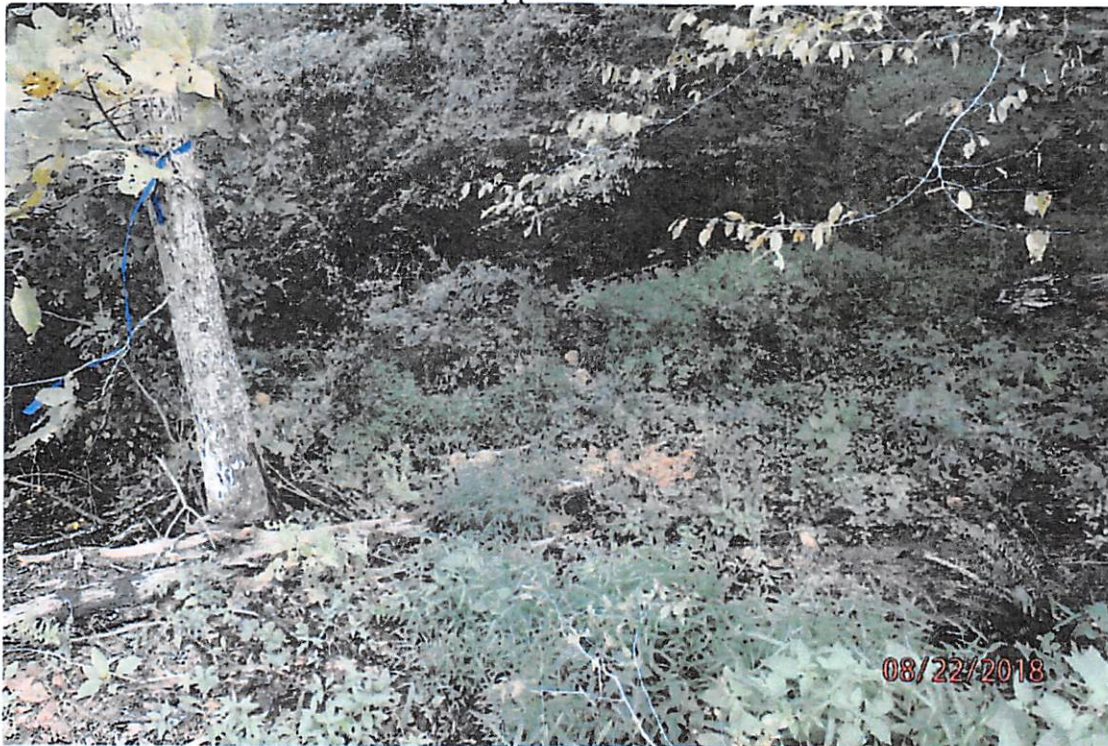
Offsite sediment deposits originating from the above pictured area.

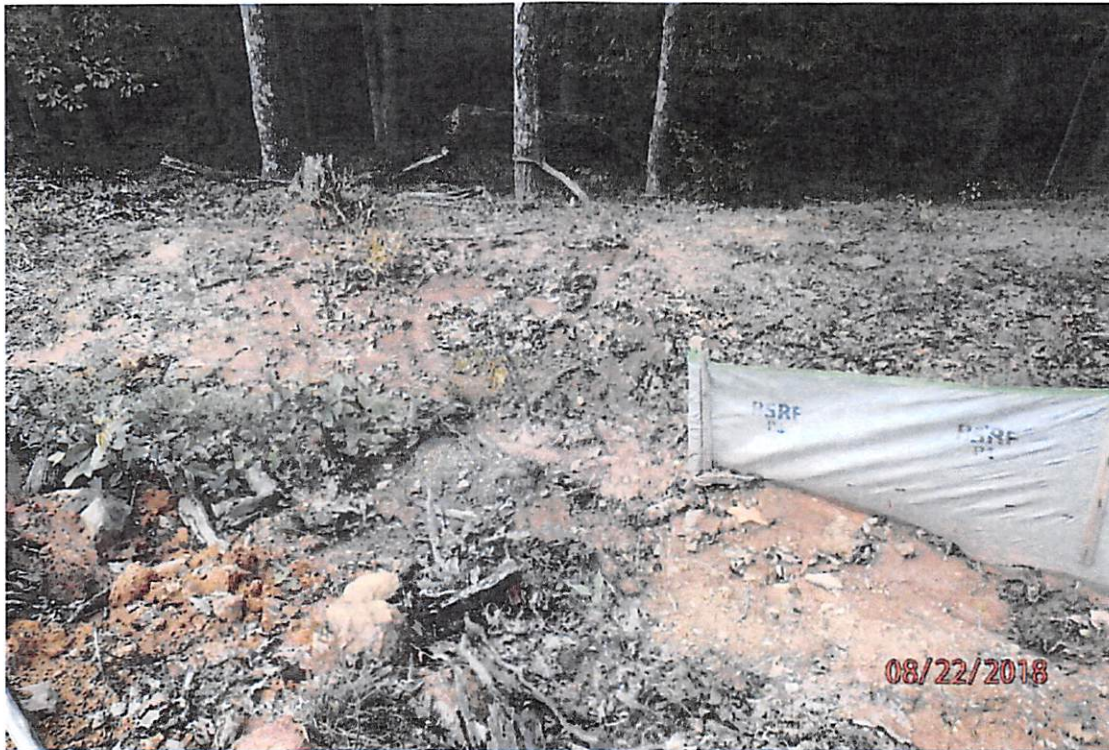
Installed perimeter control that needs to be extended in the Flint Run watershed.

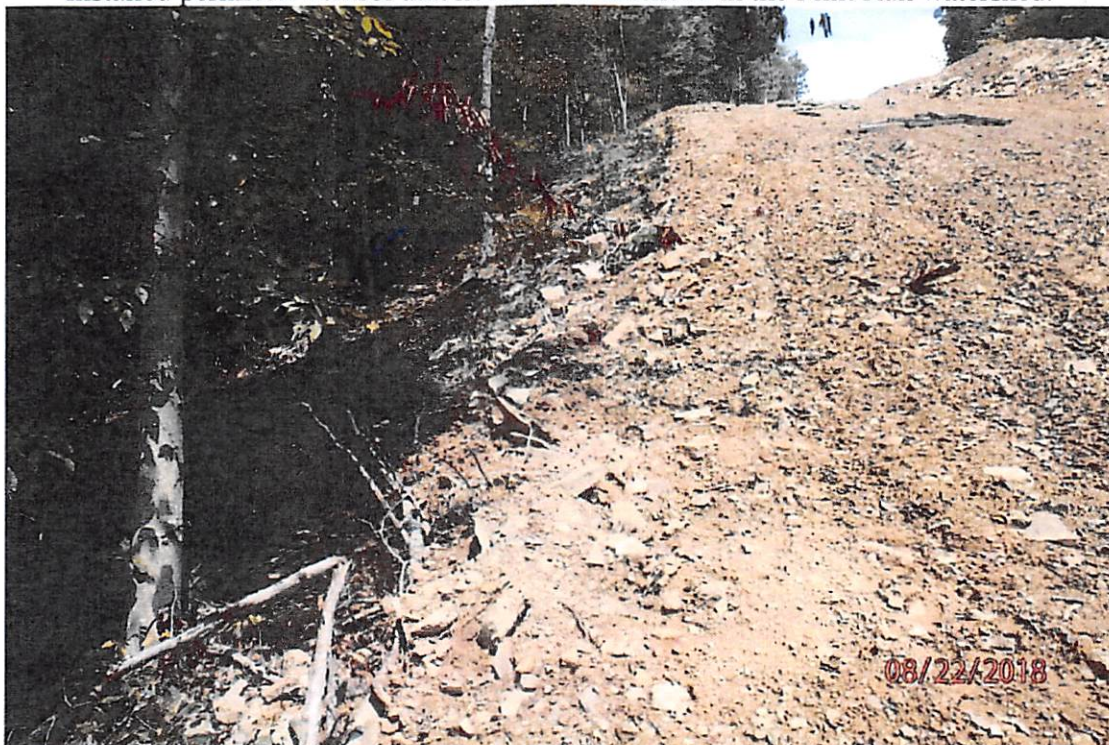
Installed perimeter control that needs to be extended adjacent to 287+95.

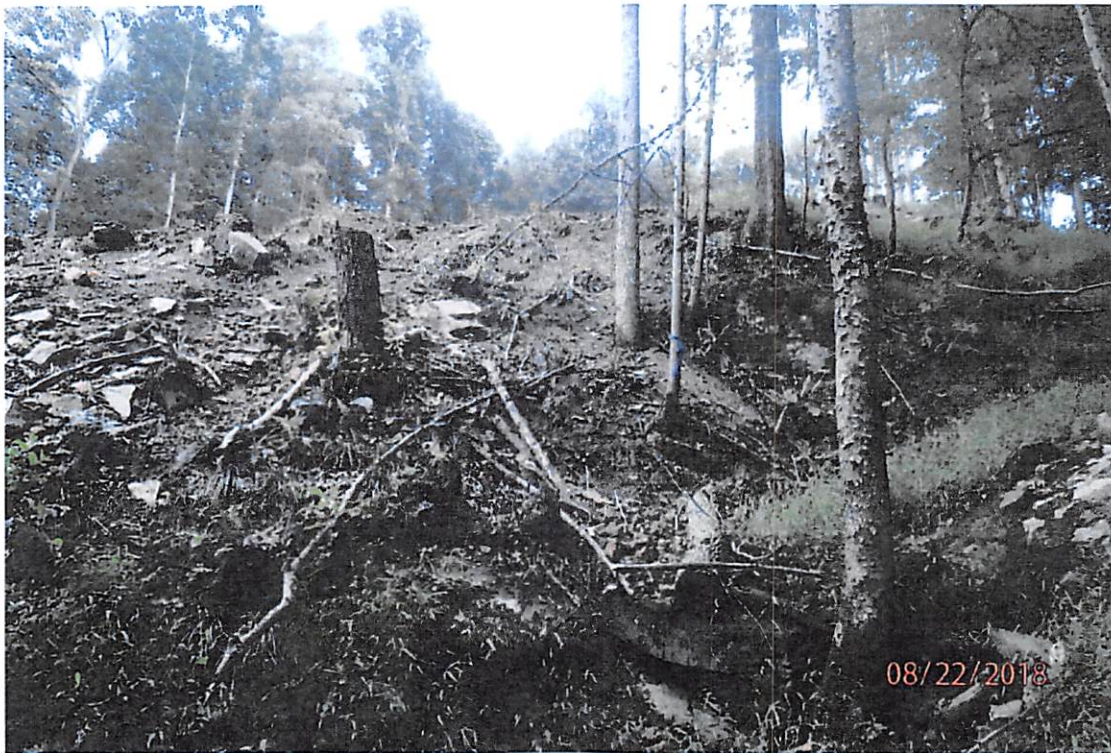
Project area adjacent to 272+00 where sediment laden water is leaving the site and no BMP is indicated on the approved SWPPP.
